## **GT-R MAIN STUD CLEARANCE PROCEDURE**

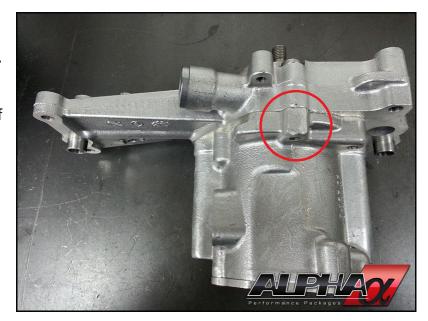
Due to added length, one of your new main studs may not provide enough clearance to allow the oil pump assembly to properly fasten to the engine. This can be resolved by machining material from the oil pump assembly. Please follow the procedures below.

If the oil pump will not fasten flat and securely when test fitting, the stud is hitting and you have a clearance issue.

The circled area is the point that is interfering with the clearance of one of the main studs.

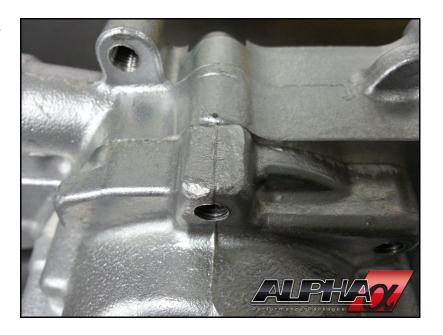
As you can see by this closeup image, this area is just a web on a boss for one of the oil pump bolts.

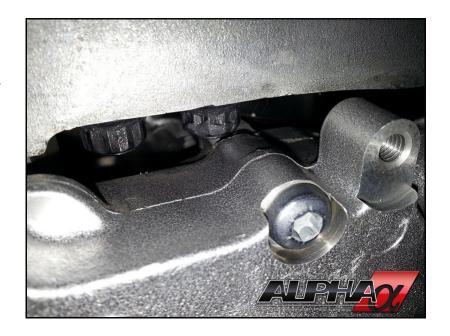
**note**: crossover tube removed for improved view.

When re-installed, check for proper clearance (as the image illustrates).
