# E4-VL-LR3

Fixes: The common wear areas in the E4OD/4R100 Accumulator Body with 1 product!

## E4-VL-23

### Three Steel 2-3 Shift Valves

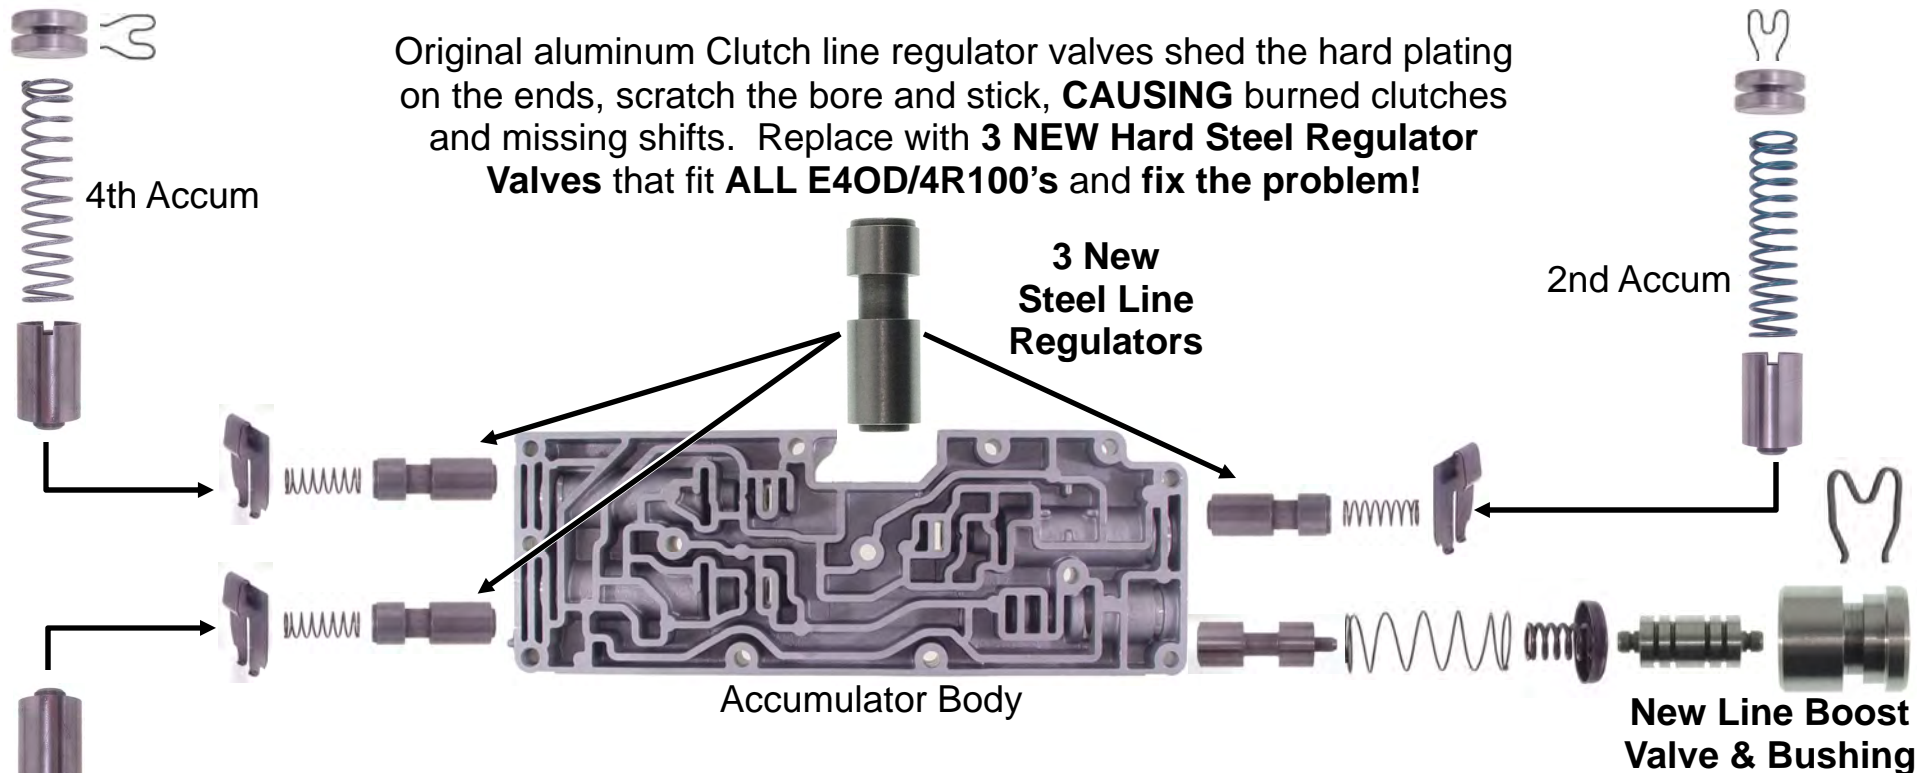
**NEW STEEL: Line Boost Valve & Bushing** replaces worn original equipment .372 diameter aluminum valve & bushing that can cause soft shifts.

Not recommended on **6 cyl units equipped** with the smaller .331 valve, as shifts will be unusually rough. **Re-use** the original .331 line boost valve (if it's not worn out)!

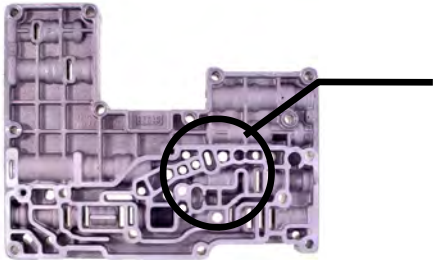
Replacement 2-3 Shift valve for Casting  
code F6 E4OD and 4R100 valve bodies.  
Fixes repeated stuck 2-3 shift valve that  
Causes no 3rd or 4th but reverse is OK.

Fits Valve bodies with 2  
or 3 SMALL balls located  
in this area and has F6  
or F8 code on main VB.

**Remove old 2-3 valve and spring. Re-use retainer.  
Install New TransGo® Valve and Blue Spring.  
THAT'S IT!**
