**INSTALLATION INSTRUCTIONS - INS201**

## 2-3/4" MID PIPE FOR BBK FULL LENGTHS HEADERS / PART# 1647/16470

Part # 1796 and 1797 // 2005 - 2008 Dodge Charger/Challenger/300c 5.7L Hemi

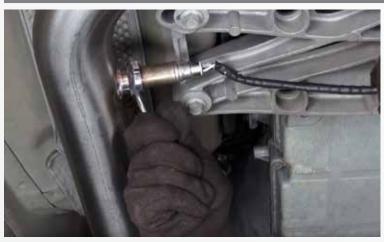
STEP 2

After installation of BBK Full Length Headers, install the matching Mid Pipes, rotate pipes as needed for alignment and fitment then start tighten at the collectors evenly and then the rear couplers ensuring the entire exhaust system is aligned correctly.

Be sure that the BBK Logo on the driver side pipe is facing the correct way when looking underneath the vehicle
