## INSTALLATION INSTRUCTIONS - INS072

# 3 PIECE ALUMINUM UNDER-DRIVE PULLEY KIT

Part # 1603 // 1988 - 1995 GM Truck 4.3L/5.0L/5.7L

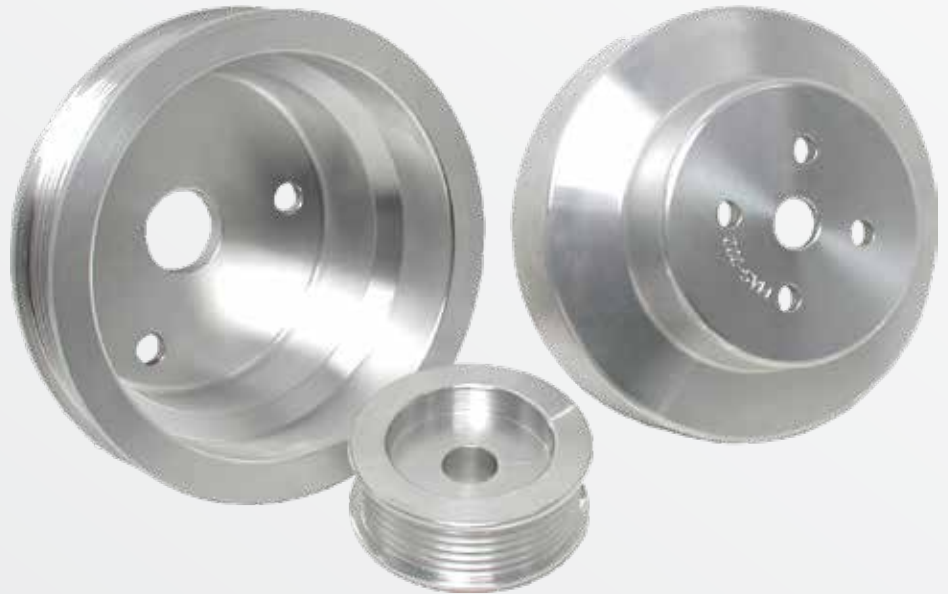
**IMPORTANT!** This pulley system requires the use of a 6 rib 91.5" length serpentine belt.
