## INSTALLATION INSTRUCTIONS - INS002

1979 - 2004 FORD MUSTANG

# BBK QUADRANT & ADJUSTABLE CABLE KITS

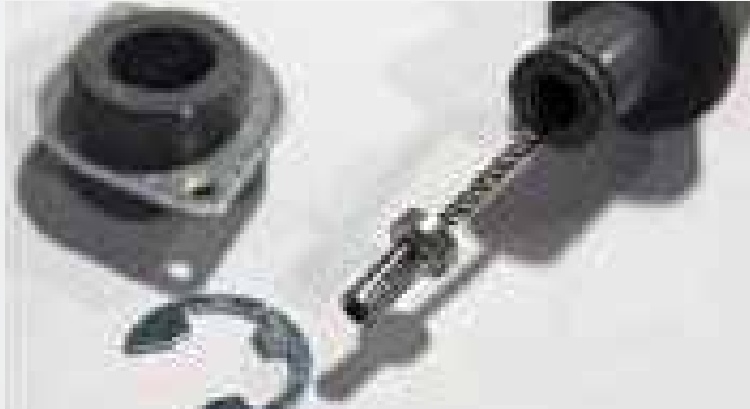
FOR KITS 15055 & 16095

1. You need to remove the rubber bushing from the cable by removing the metal clip with a small screwdriver.
2. Feed the end of the cable down to the bell housing and slide it through the hole in the bell housing, position the threaded end of the cable through the clutch fork.

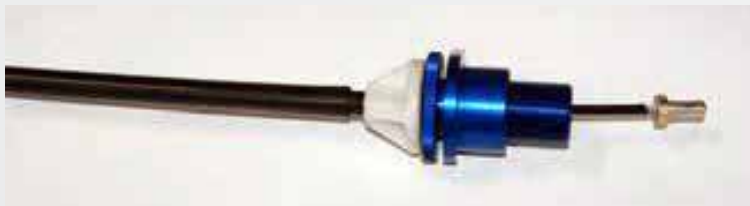
3. Feed the clutch pedal end of the cable and housing into and through the BBK firewall adjuster.
4. From under the dash, position the cable end onto the clutch quadrant.
